# Measuring the Settlement and Shoreline Change of a Large Marsh Creation and Foreshore Rock Dike Project Over Time and Hurricane Disturbance

State of Coast Conference (SOC25)  
May 20-May 22, 2025  
Ernest N. Morial Convention Center  
New Orleans, LA

# LITTLE LAKE SHORELINE PROTECTION/DEDICATED DREDGING NEAR ROUND LAKE (BA-37)

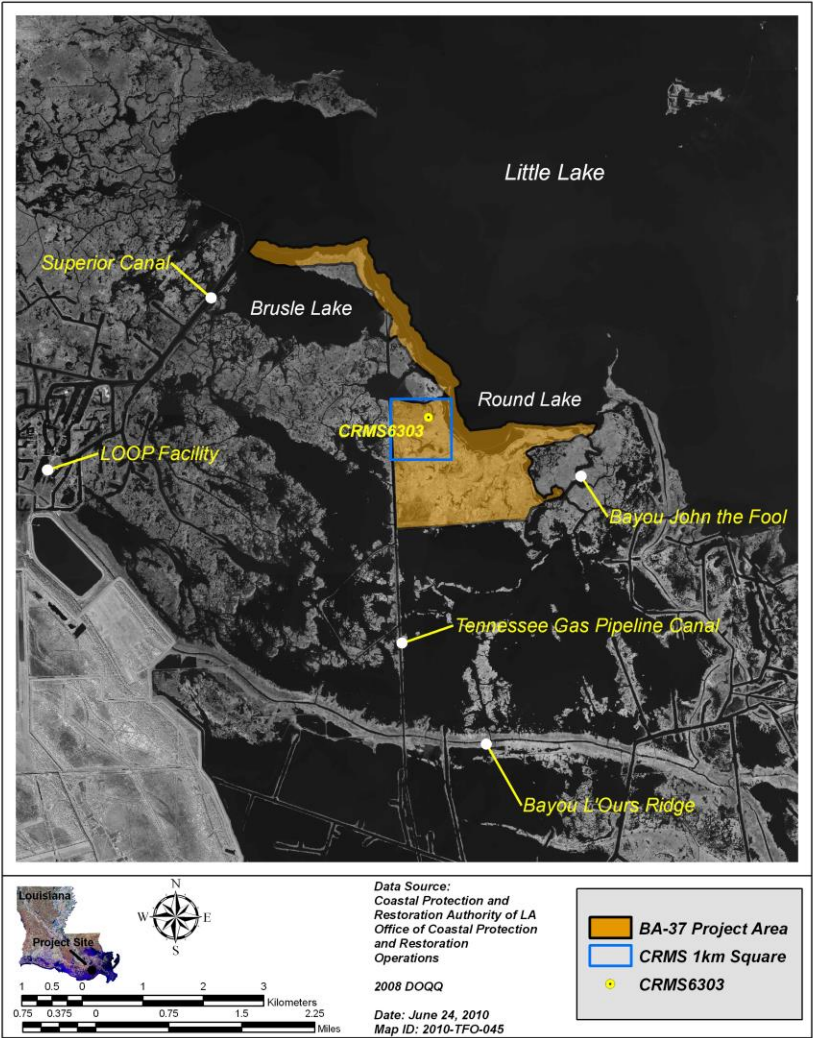
# Pipeline Canal Construction, Tidal Scouring, & Vegetation Die-back Drawings Obtained from Gagliano and Wicker 1989

BA-37 Vicinity & Land Loss

Tidal Scouring

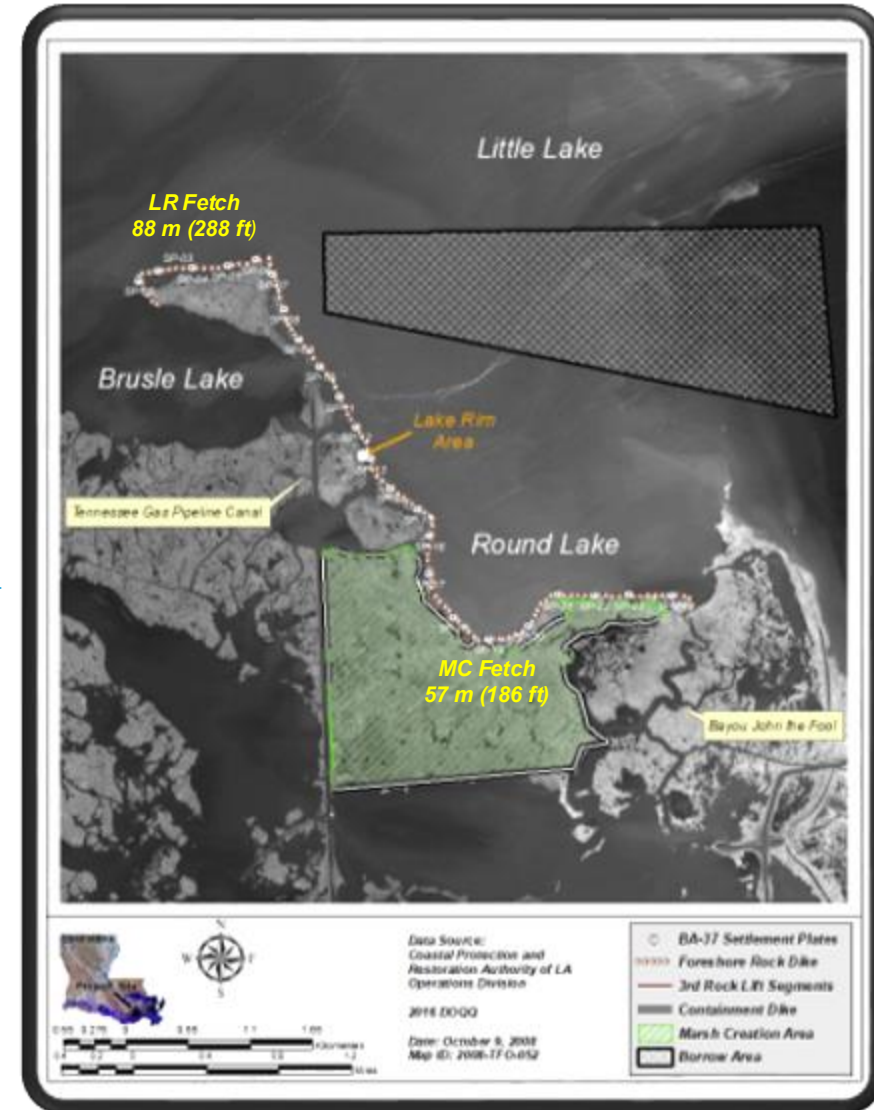
# BA-37 Pre-con & As-built Project Features

Pre-con Marshes

Project Features

- **GOALS & CONSTRUCTION**
  - REDUCE THE MARSH EDGE EROSION RATE
  - MAINTAIN 799 ACRES (323 HA) OF MARSH FOR 20-YEARS
  - NOV 2005-FEB 2007
  - FORESHORE ROCK DIKE 2.5-4.0 FEET – 5 MILES IN LENGTH
  - MARSH 2.36 FEET – 920 ACRES CREATED OR ENHANCED

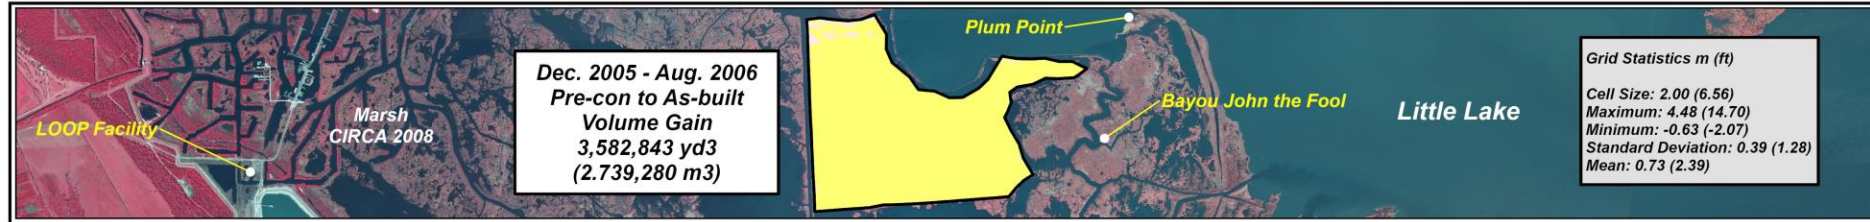
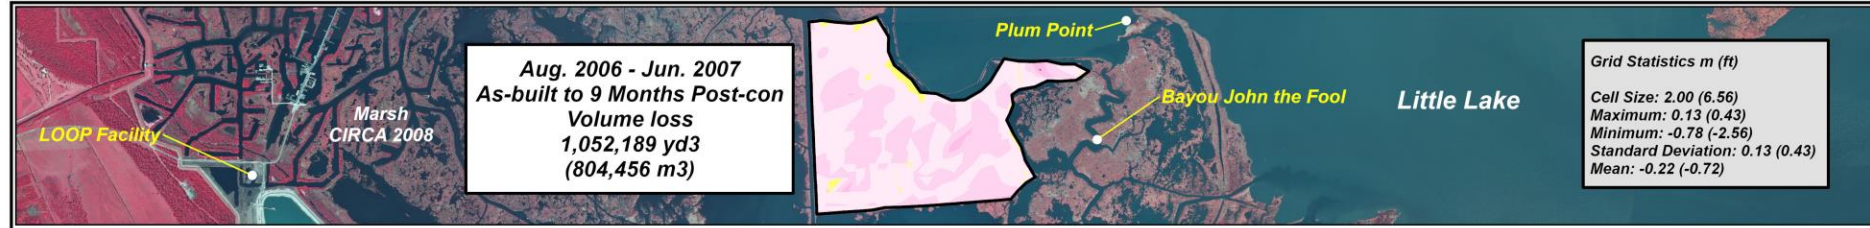
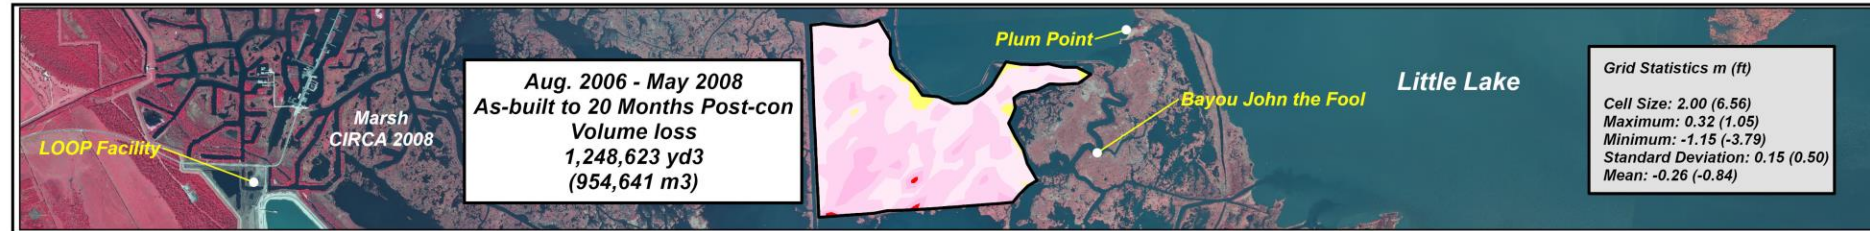
# BA-37 2006-2009 Elevation Change Models

- Pre Hurricane Ida
- Created 920 Acres of Intermediate Marshes
- Subsided at a Slower Rate Than Predicted Settlement Curve
- MC Area Erosion Rates Significantly Different from Pre & Lake Rim
- LR Erosion Rates Lowered Except During High Energy TS Events
- Post Hurricane Ida
- MC Area Lost Acreage but Approx. 650 Acres Remain Due to Mineral Additions
- MC Area Gained Elevation After the Storm
- Only 9.0 Acres of the LR Remains
- Surrounding Marshes Lost Approx. 25,000 Acres
- All that Remains of the Clovelly Marshes are Ridges, Spoil Banks, & BA-37
- Two Restoration Projects Planned but Comprehensive Restoration Plan Needed

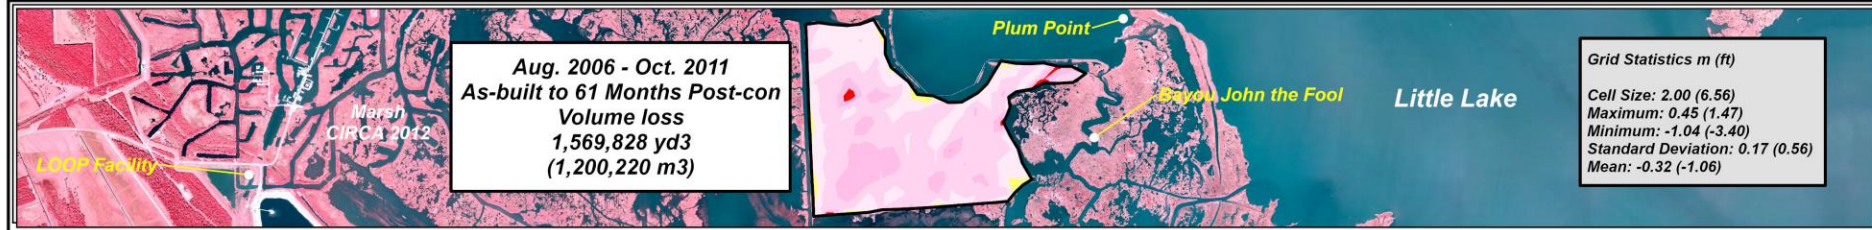
# BA-37 2010-2022 Elevation Change Models

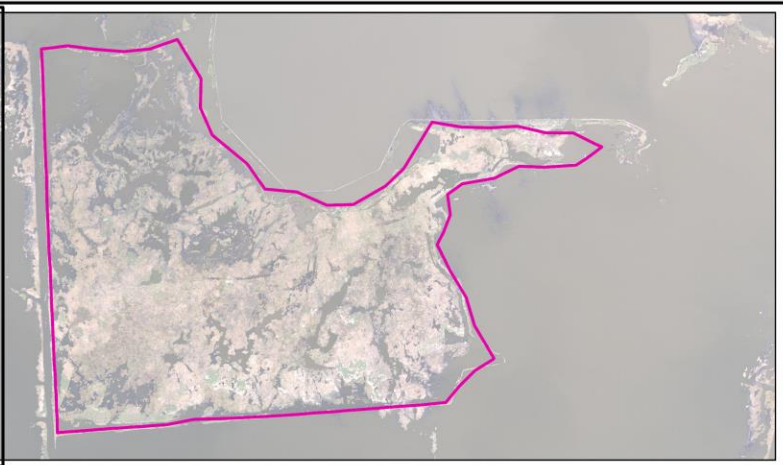
# BA-37 2016-2021 Elevation Change Model & As-built Fill Analysis

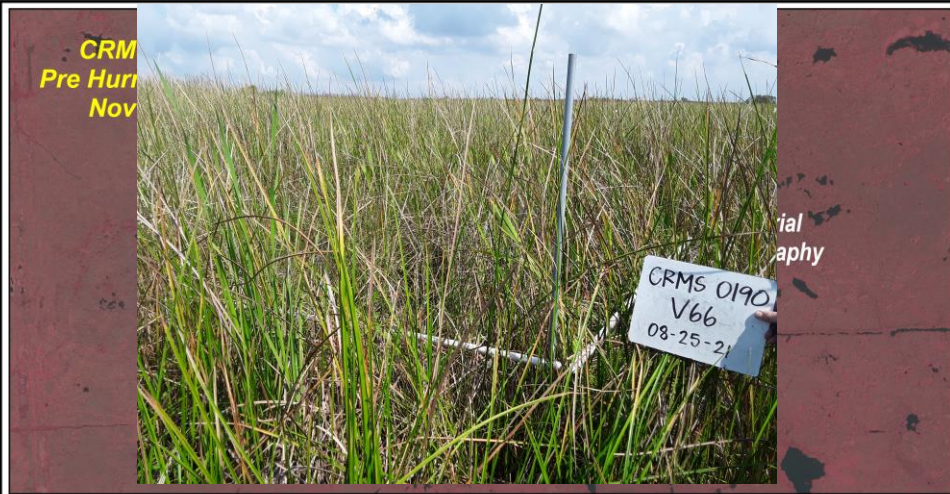
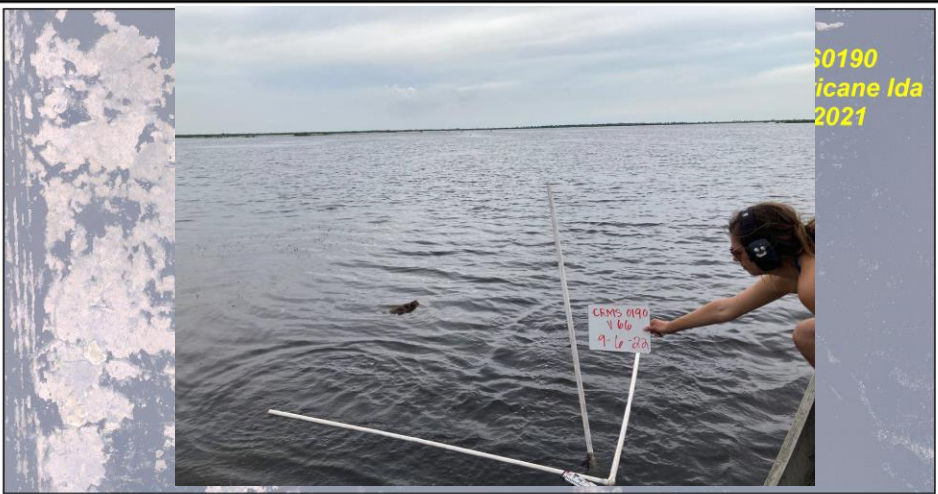
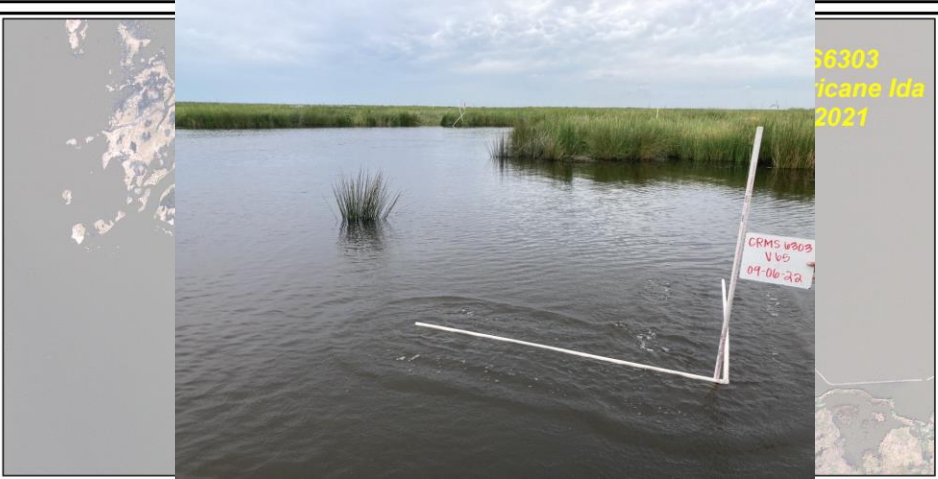
# CRMS6303 & CRMS0190 Analysis

CRMS Squares  
1Km Aerial  
Photography Area  
200m Data  
Collection Area

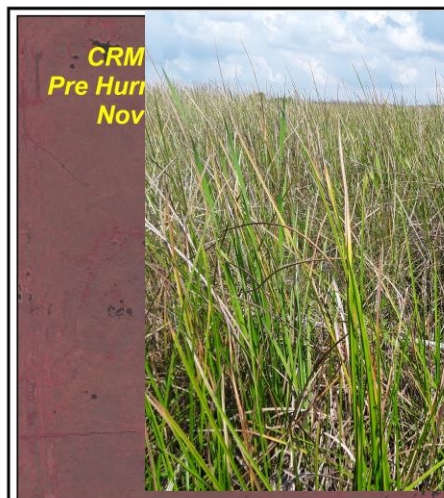
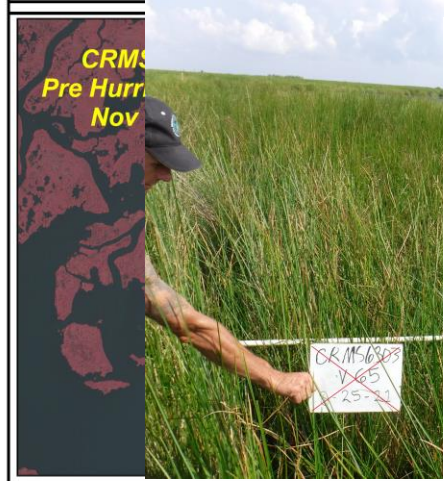
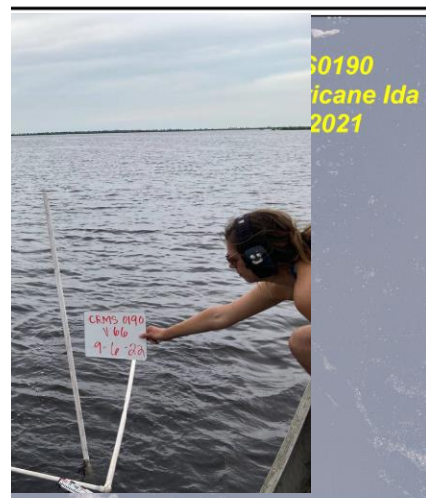
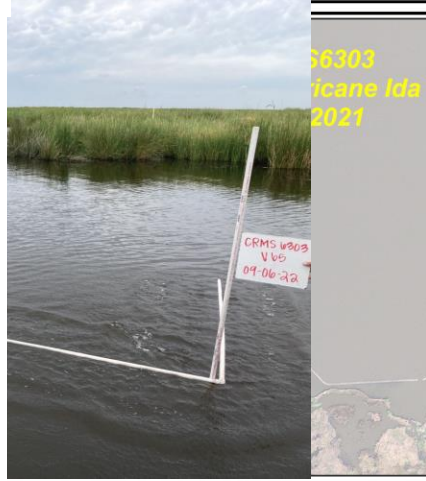
# CRMS6303 & CRMS0190 Analysis

CRMS Squares  
1Km Aerial  
Photography Area  
200m Data  
Collection Area

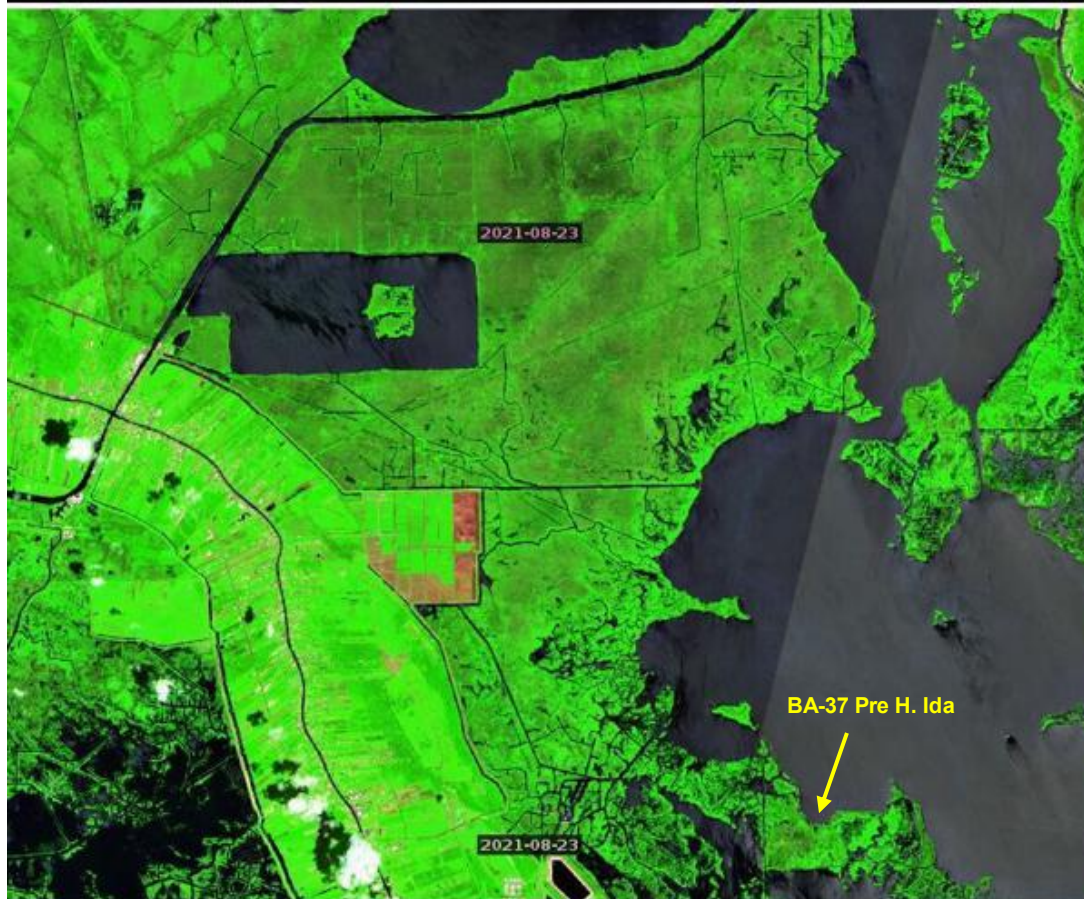
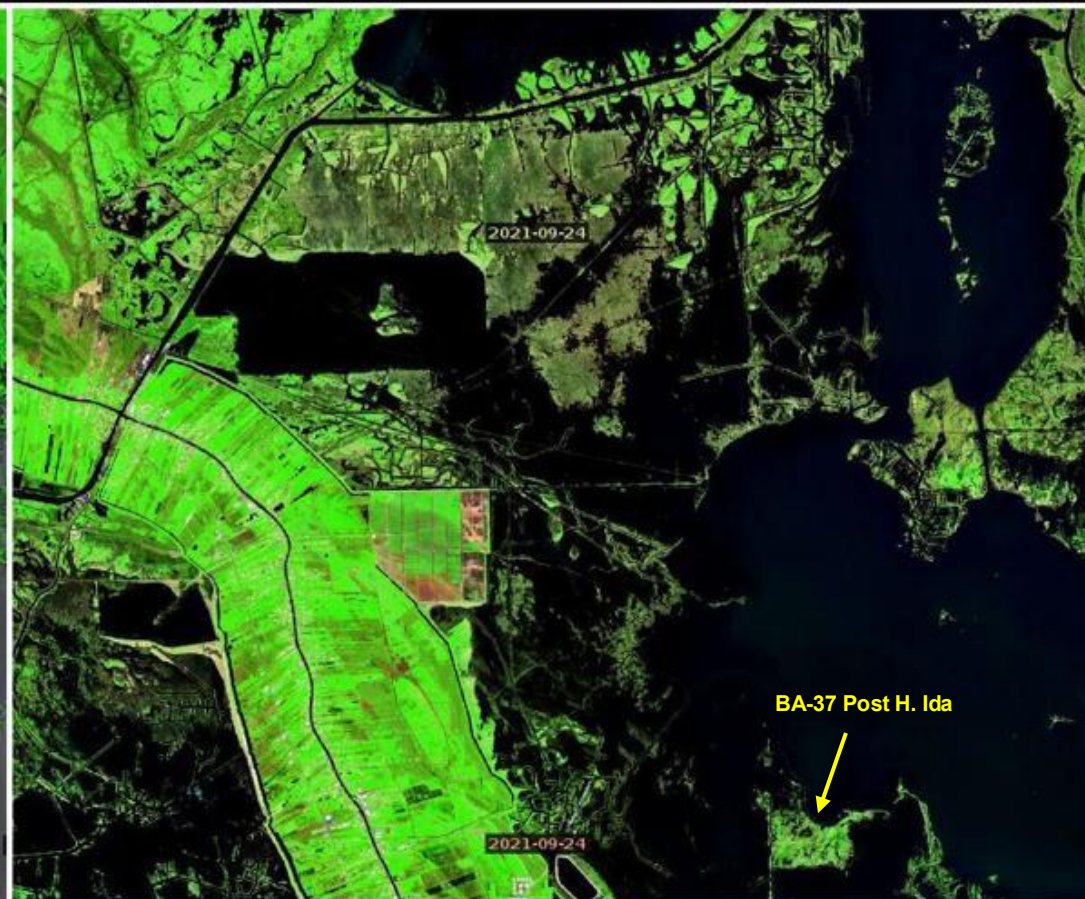
# Hurricane Ida Clovelly Marsh Loss

## Pre/Post Visual Comparisons

August 21, 2021 (Sentinel-2)

September 24, 2021 (Sentinel-2)

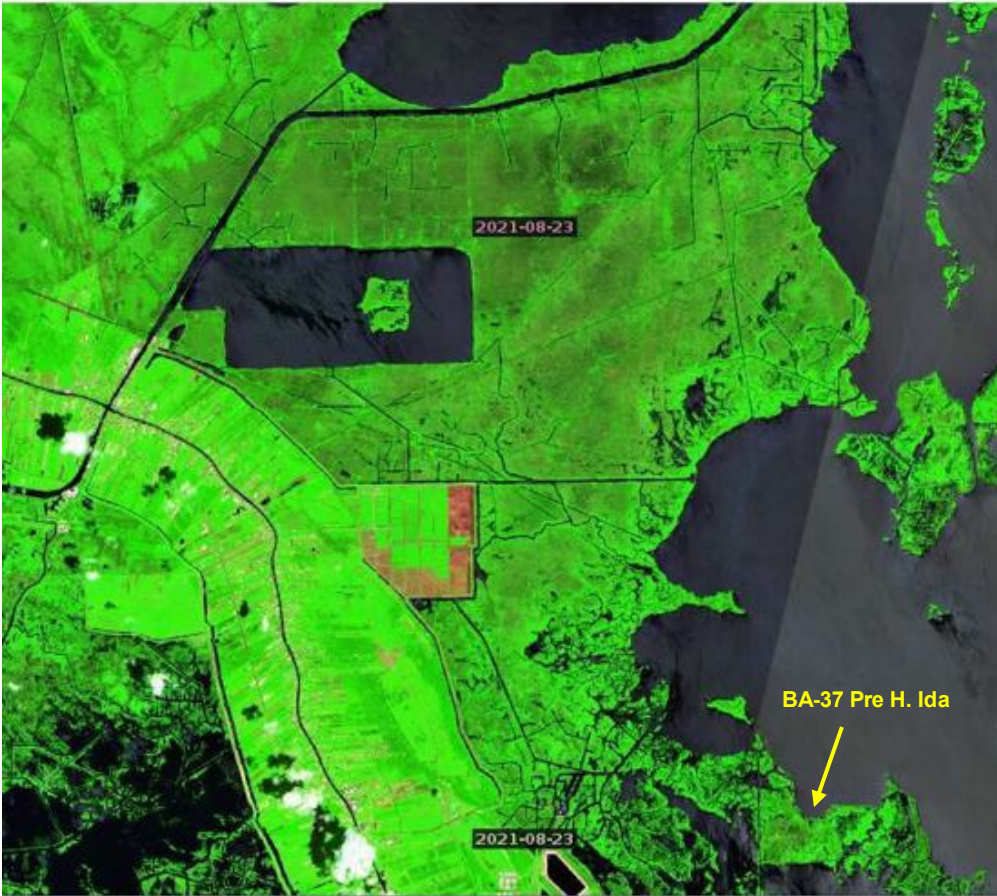
# Hurricane Ida Clovelly Marsh Loss

## Pre/Post Visual Comparisons

August 21, 2021 (Sentinel-2)

September 24, 2021 (Sentinel-2)
