Accelerating Elevation Gain Indicates Land Loss Associated with Tidal Erosion at CRMS sites

LEIGH ANNE SHARP - COASTAL RESOURCE SCIENTIST, SR - LAFAYETTE REGIONAL OFFICE

Louisiana's Coastwide Reference Monitoring System (CRMS)

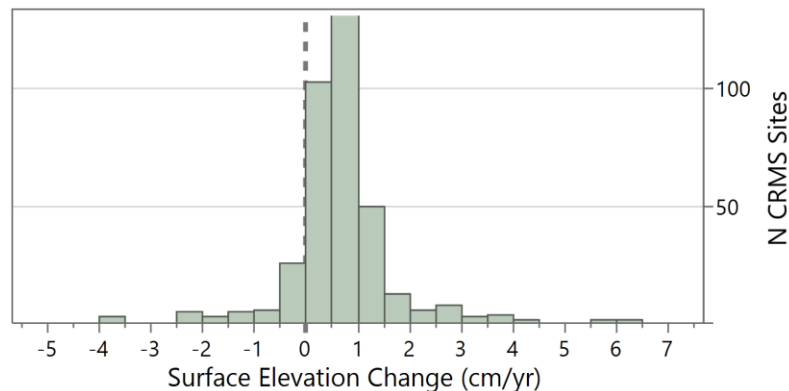
Most CRMS sites see Surface Elevation Gain

- SEC rates have been positive since CRMS data collection began.
- Highest rates in deltas and on the lower Deltaic Plain where landloss continues.

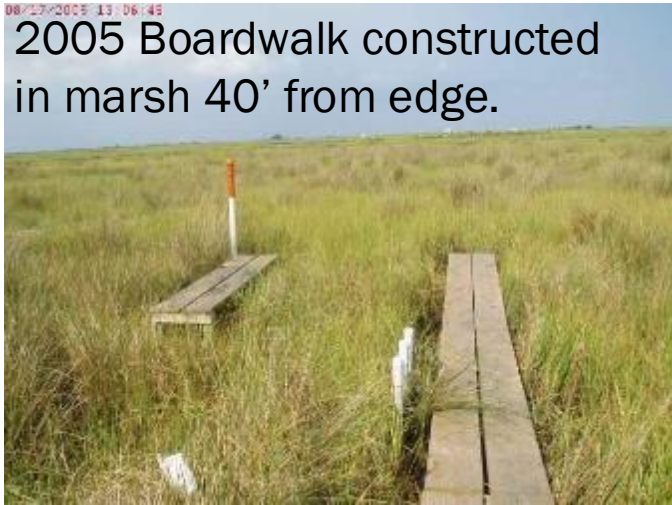
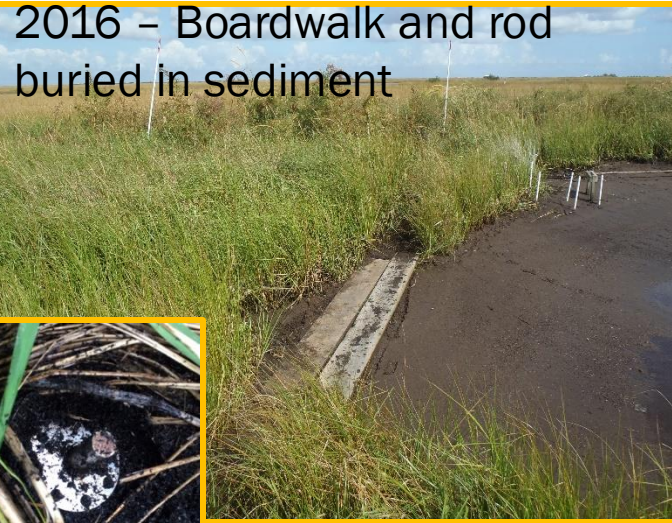
Rapid Erosion - High Elevation Gain + Landloss - BA Basin CRMS0174

Delta Scale Elevation Gain (3.8 cm/yr)

2017 - Due to very high sediment deposition, rod extended and collar raised

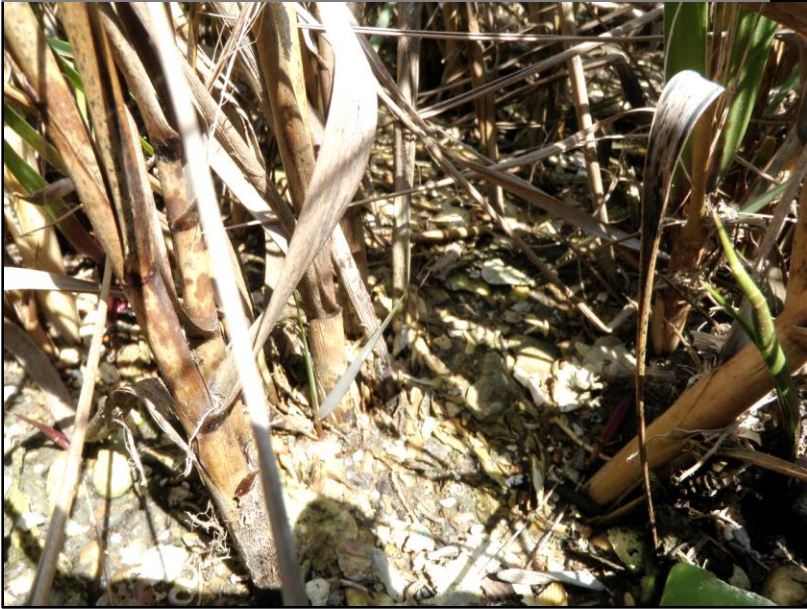
CRMS0302 Soil surface 2014

– Note shell hash and hearty stems

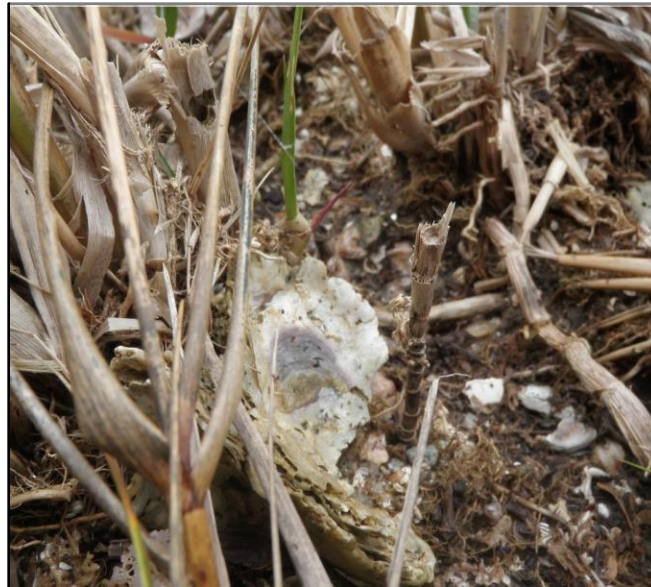
CRMS0302 Soil surface 2015

– Note exposed roots and broken stems

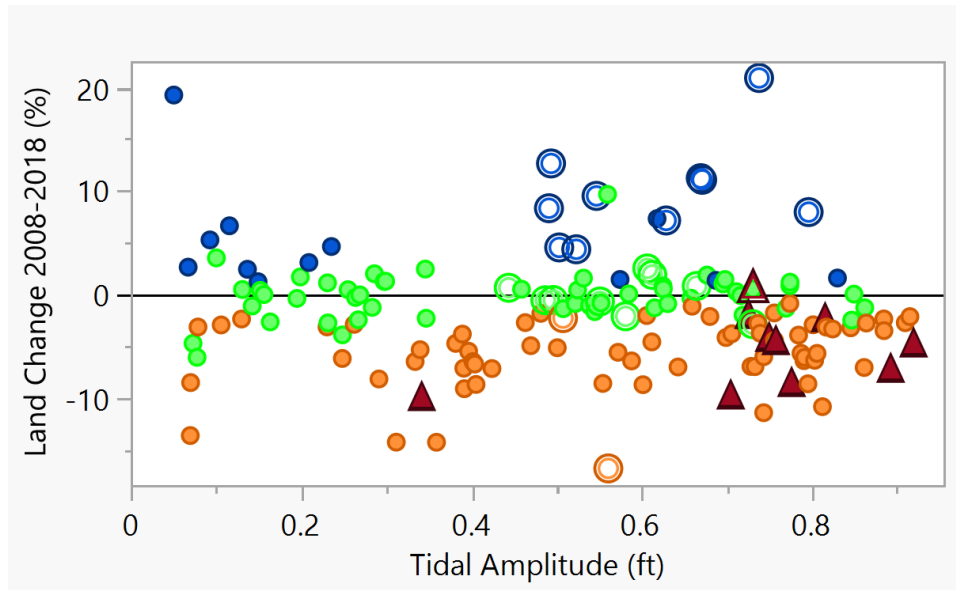
Land Change Classification

- Identified sites that had lost all vegetation pre Ida (n=10 sites; red triangles).
 - Most had tidal amplitude > 0.7'; outlier in Breton Sound
- Classified sites as Gaining Land, Losing Land or Oscillating using 2008 and 2018 USGS spatial analyses.
- Explored relationships between elevation gain, acceleration, and land change.

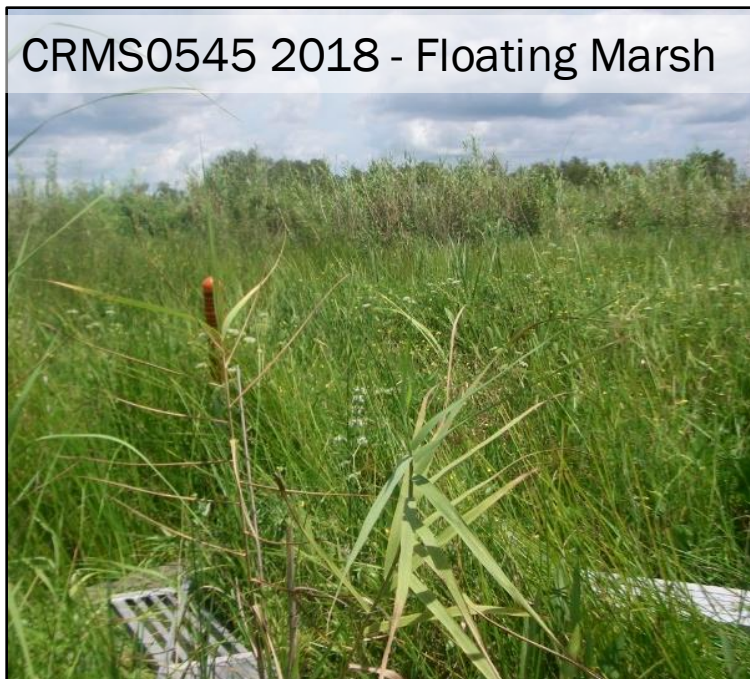
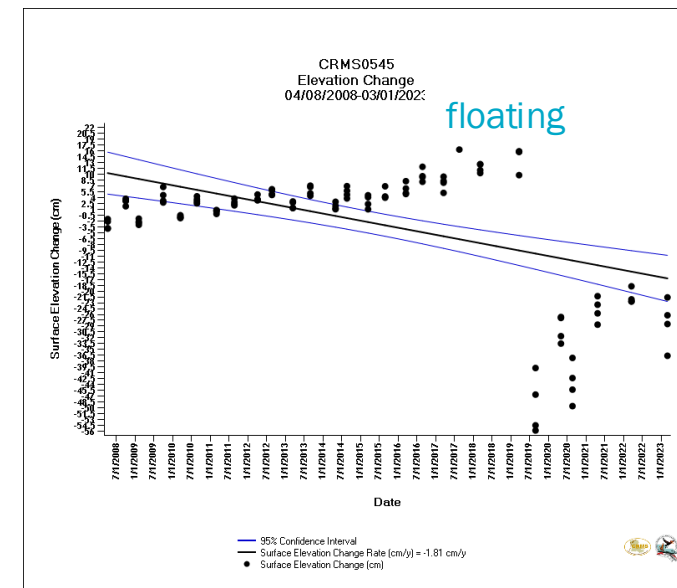
Mat Detachment and Landloss - TV Basin Intermediate Marsh

- The marsh surface at CRMS0545 was observed to detach (began to float) in 2017.
- Land remained stable.
- The floating vegetation was removed by H. Barry in 2019 and hasn't recovered.
- *This can also be characterized as accelerating elevation gain with landloss though it is not tidal erosion.*
- Mat detachment and related vulnerability contributes to landloss during hurricanes.
- Shallow expansion contributes to elevation gain and is observed more frequently in high water years.
